NATIONAL TRANSPORTATION SAFETY BOARD

SPECIAL INVESTIGATION REPORT

TANK CAR STRUCTURAL INTEGRITY AFTER DERAILMENT

NTSB-SIR-80-1

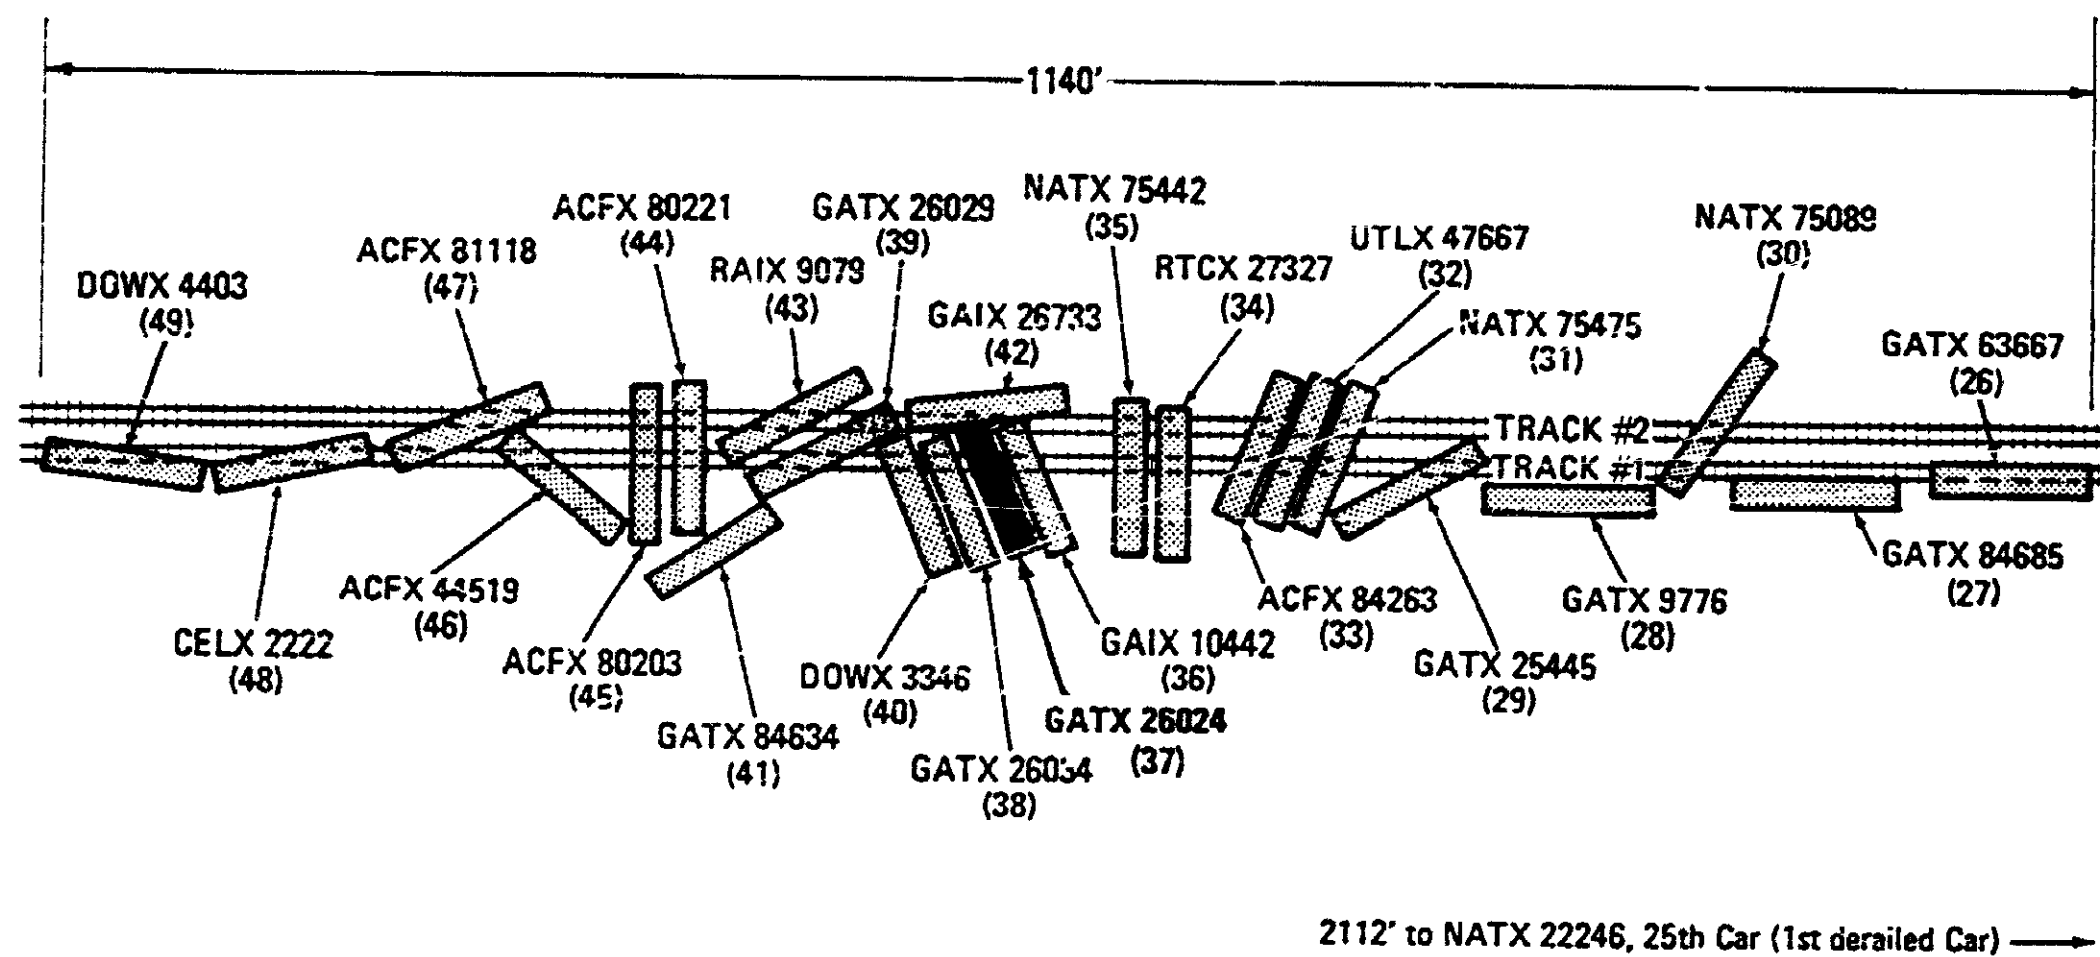
Figure 1.--Plan view of accident site.

About 5:45, e.s.t., on November 8, 1979, cars 25 through 49 of Conrail freight train IHEN-8 derailed 1 mile east of Inwood, Indiana. The train consisted of 3 locomotive units, 90 cars (76 loaded and 13 empty), and a caboose. Twenty-four of the 25 derailed cars contained hazardous materials. The shipments included: one acetic anhydride, one butyl cellosolve, one butyl methacrylate, six ethyl acrylate, two ethyl chloride, two ethylene oxide, one isobutyl alcohol, one methacrylic acid, one propylene naphtha, one propylene oxide, one sodium hydroxide, and five vinyl chloride. Eight of the derailed hazardous materials cars released some product. (See figure 1.) The Safety Board conducted a field investigation of this accident.

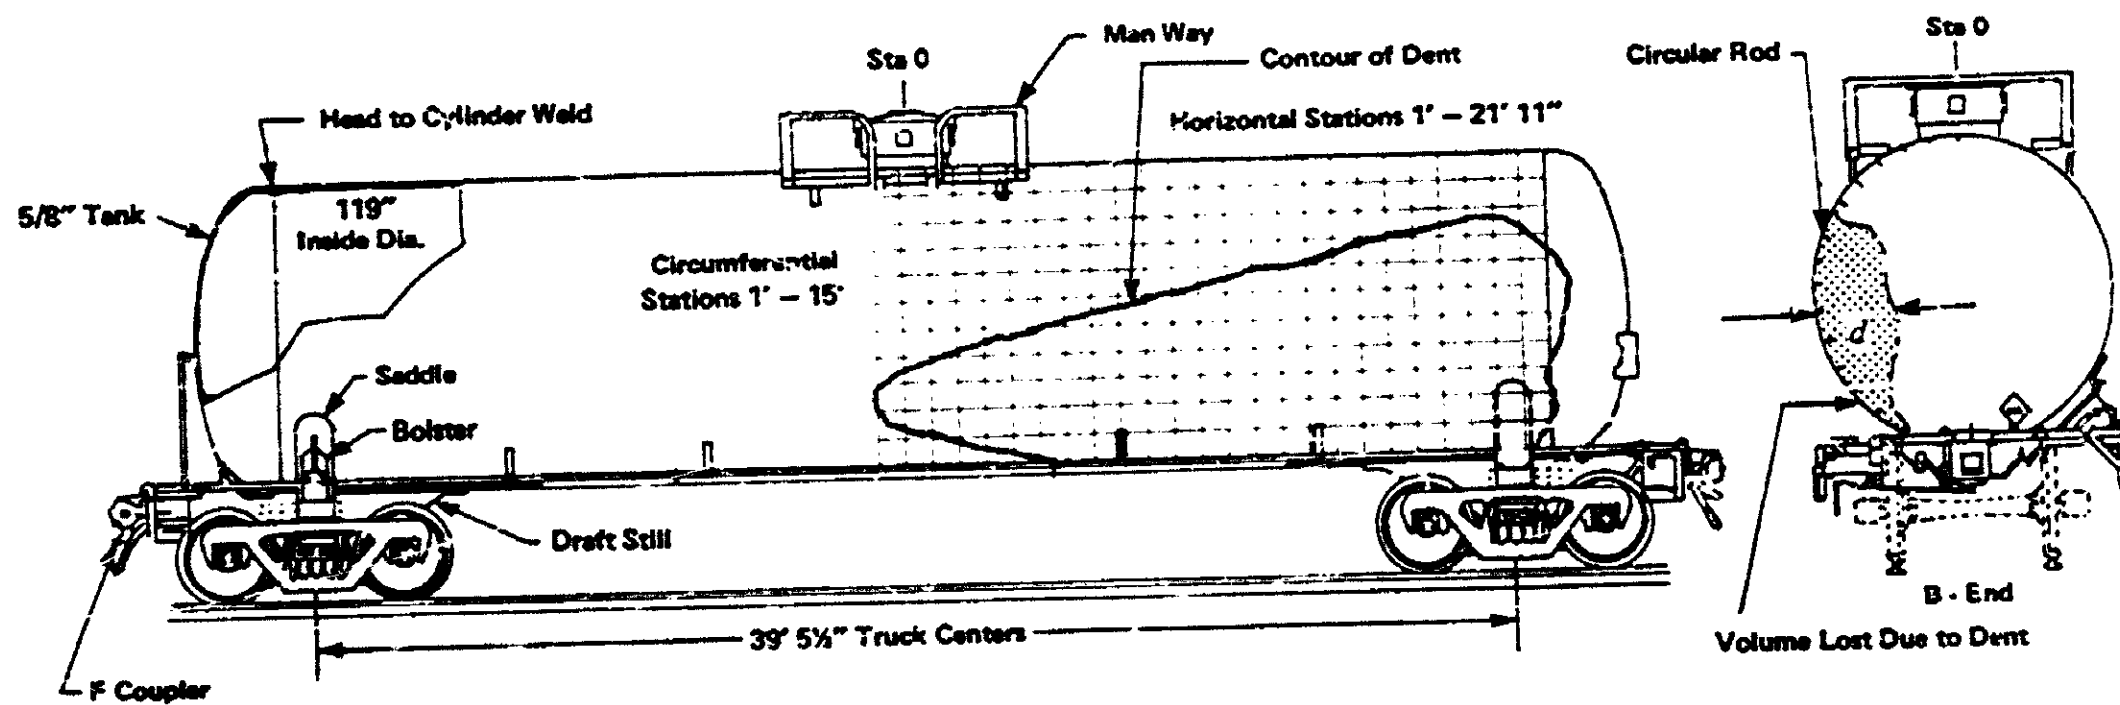
Figure 3.—Tank car nomenclature and measurement scheme.

Based on the measurements taken from an established line representing the original tank contour and the cardboard radii templates used to determine the bend radii, computer calculations indicated that the decrease in the interior volume of the tank was approximately 1,092 gallons, or 4.2 percent of interior volume. (See figures 3 and 4, and appendix B.)

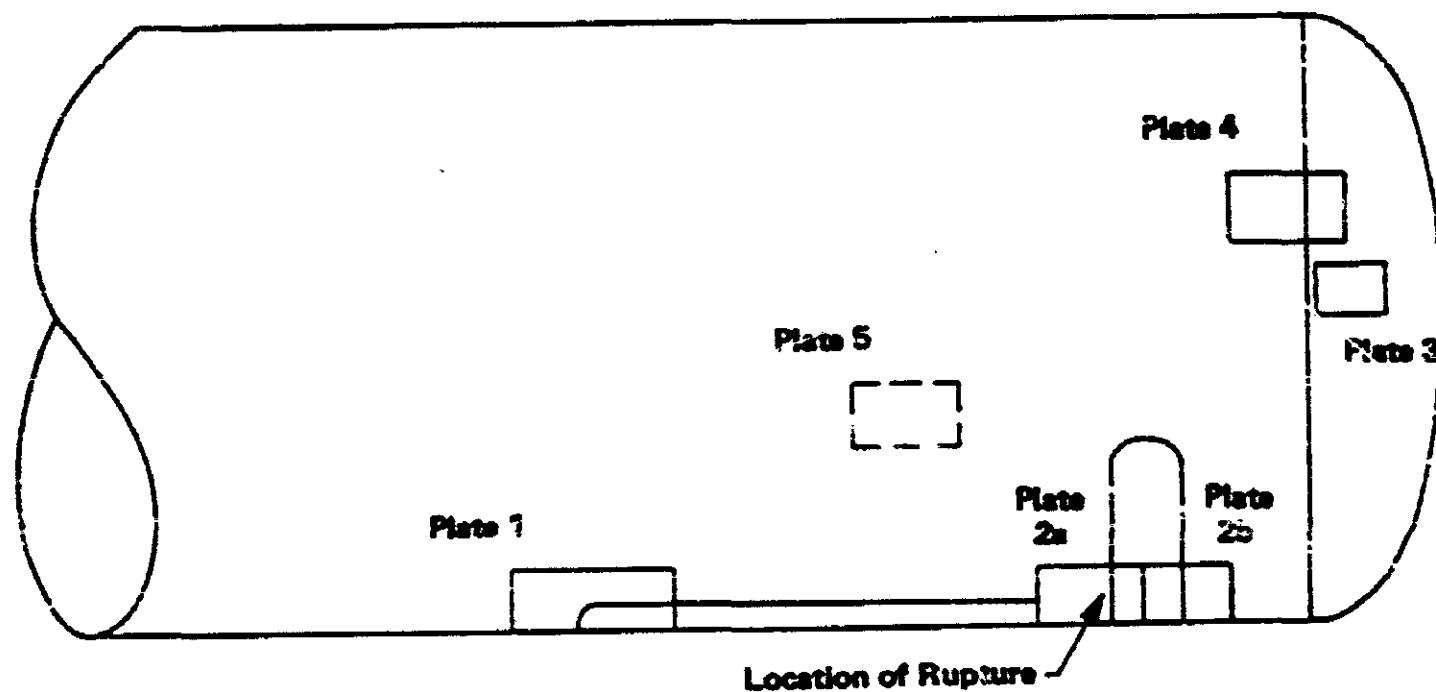
Figure 7.--Metallurgy sample locations.

- (1) Metallurgical Coupon Areas.--Metallurgical testing was conducted on the lower left end of the tank at the draft sill reinforcing plate; lower left end of the tank at the bolster reinforcing plate and the bolster saddle plate; lower right end of the tank at the bolster reinforcing plate and the bolster saddle plate; middle section of the tank head at the maximum bend of the tank head; upper section of the tank-to-head weld at maximum radius bends; and middle right side of the tank (out of the damage area.) (See figure 7.)

Coupon No.	Location (See Appendix B)		Purpose
	Circumfer.	Horizontal	Determine
1	14 - 15	11 - 12	Weld strains, effectiveness of stress relief
2a	13 - 14	19 - 20.5	Failure analysis
2b	14 - 15	19 - 20.5	If cracked in weld & bend radius
3	9 - 10	21 - 22	If cracked in worst head bend radius
4	7 - 8	20 - 21	If cracked in worst bend in weld
5	opposite side		Physical properties, unstrained
